Premier Inspections LLC
5545 Mountcastle Road
Providence Forge, VA 23140
804-387-1747
steve@premierinspectionsva.com www.premierinspectionsva.com

Confidential Inspection Report

999 Easy Street

12/22/2023

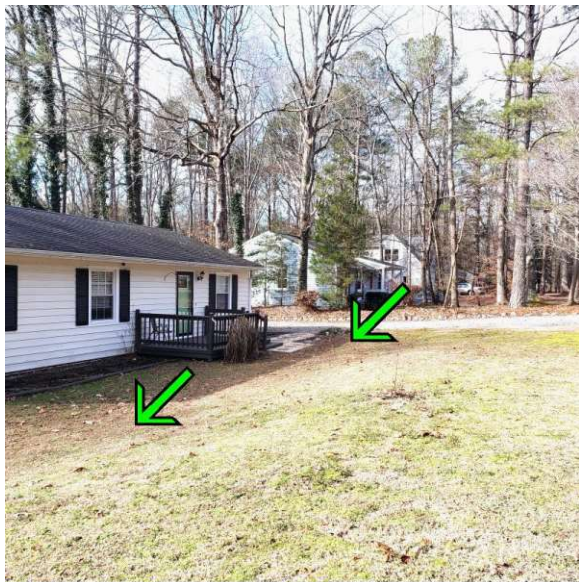
ACTION - REPAIR: Recommend correction by qualified licensed landscaper or grading contractor. Soil surface was flat or was sloped towards structure (negative grade). Poor grading could allow water to drain towards the structure or collect around the foundation walls and cause foundation or structural issues. Recommended ground slope away from the foundation is at least 1/2 inch per foot for a minimum of 6 feet. If proper ground slope cannot be achieved, it may be necessary to install a swale (see attached graphic).

Front yard slopes towards house

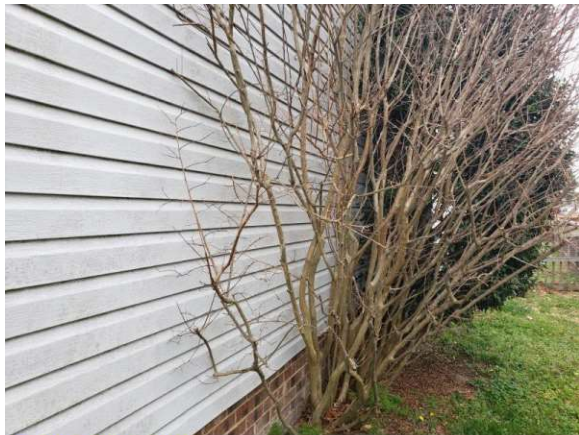
Right rear corner

ACTION - REPAIR: Shrubbery in contact with siding or structure. Trim shrubbery so there is an 8 - 12-inch gap between shrubbery and siding to prevent siding damage.

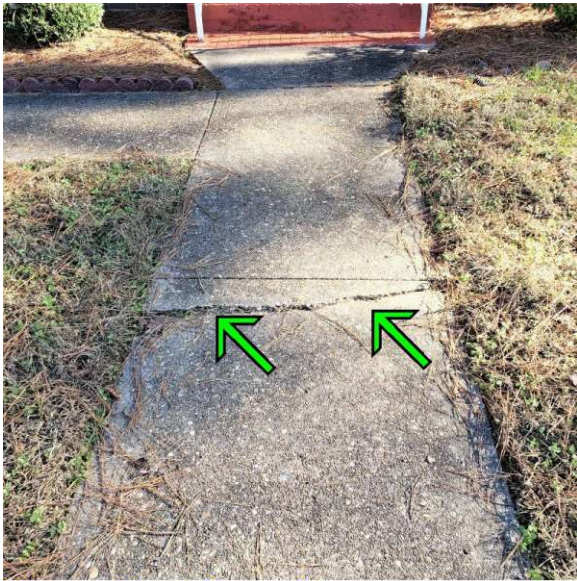
ATTENTION - MONITOR: Monitor closely for change in condition and need of repair by qualified licensed contractor. Minor uplifting in walkway surface.

Minor uplifting in front walkway

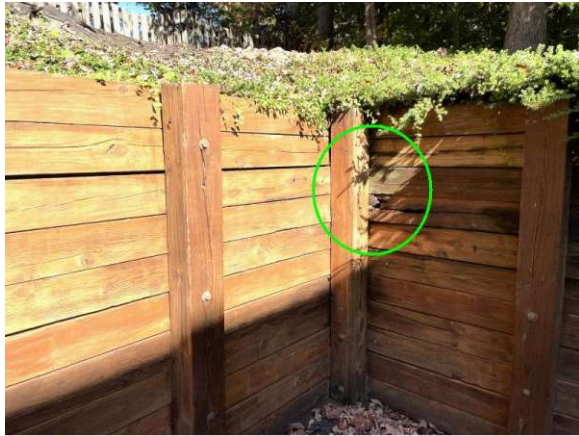
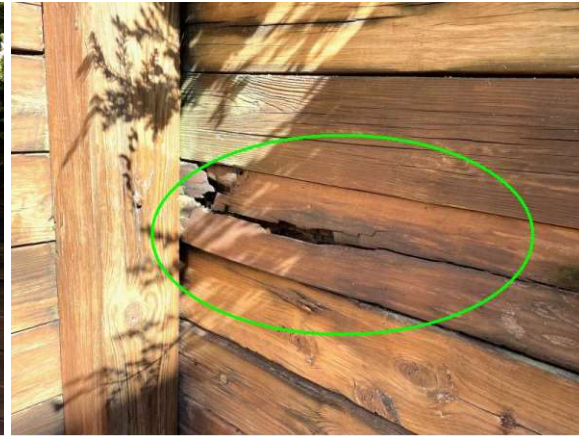
ACTION - REPAIR: Recommend repair by qualified licensed contractor with retaining wall experience. Damage to wall surface in left rear corner.

Close-up of damaged area

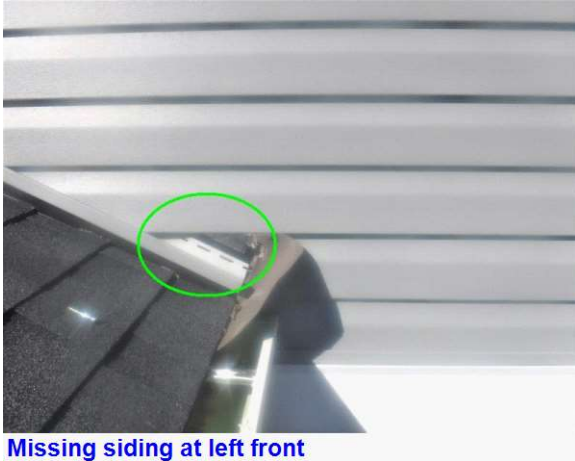
Siding Condition:
Siding appeared functional with following exception: **ACTION - REPAIR:** Recommend repair by qualified licensed contractor to prevent water intrusion and structural damage. Missing siding at left front.

Missing siding at left front

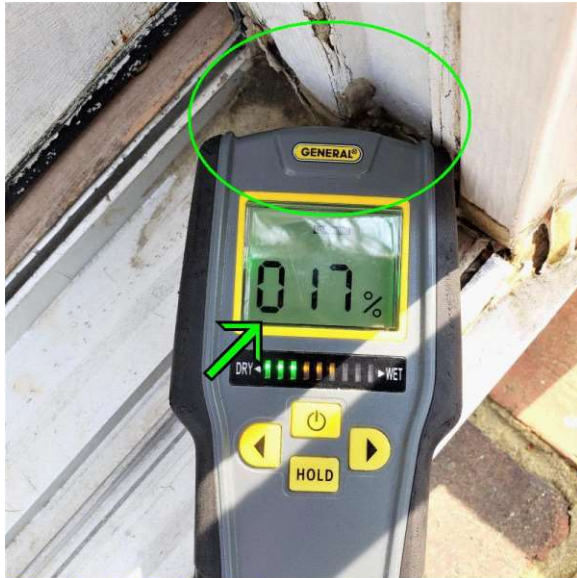
ACTION - REPAIR: Recommend repair by qualified licensed contractor. Wood rot. Moisture meter showed 17% moisture level. Lower right corner of door frame / trim.

Wood rot / High moisture content

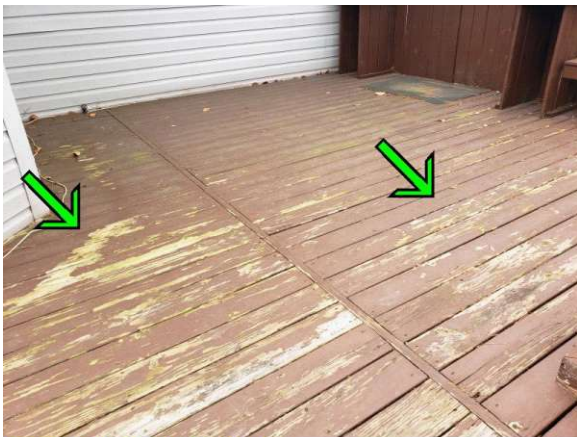
ACTION - REPAIR: Recommend repair by qualified licensed contractor. Painting or staining needed to prevent deterioration and weather damage.

Paint / stain deck surface

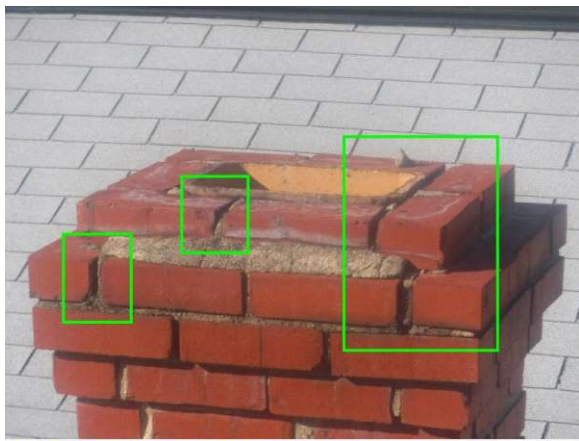
Masonry. **ACTION NEEDED - REPAIR** - Recommend repair by a qualified licensed contractor to prevent water intrusion and moisture damage to the chimney stack. Masonry cap cracked, broken or deteriorated.

Missing / damaged mortar on chimney cap

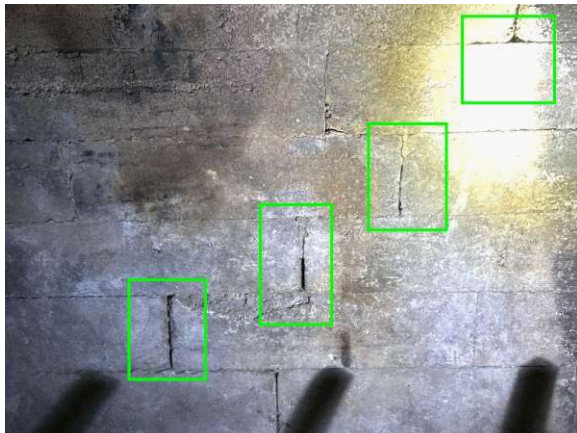
ACTION - REPAIR: Recommend repair by qualified licensed contractor. Damaged, loose or missing mortar in firebox. Heavy creosote build-up.

Cracked / missing mortar in firebox

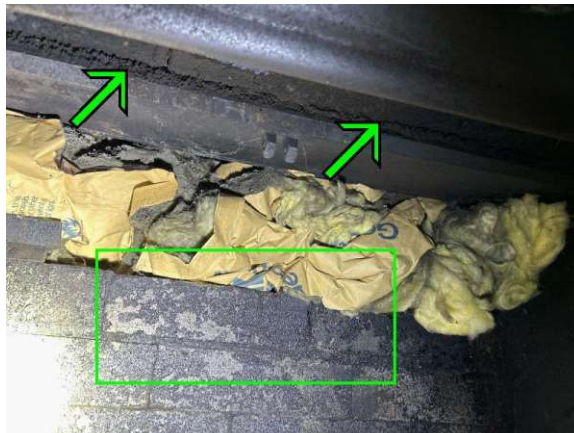
Creosote build-up at damper

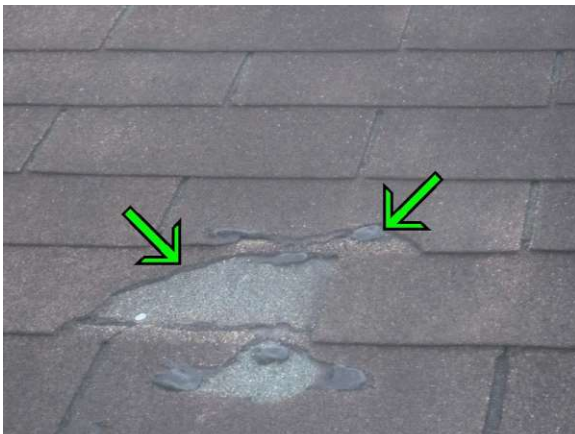
ACTION - REPAIR: Recommend repair by qualified licensed roofing contractor to prevent water intrusion and roof / structural damage. Damaged shingle(s).

Shingle damage / Right front

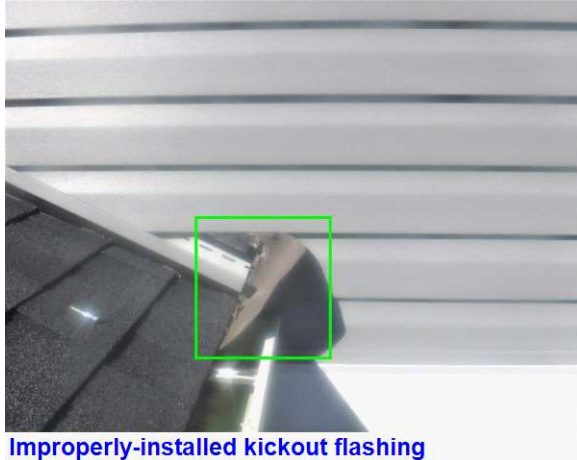
ACTION - REPAIR: Recommend repair by qualified licensed roofing contractor to prevent water intrusion and roof / structural damage. Kickout flashing improperly installed. Kickout flashing should turn at about a 120-degree angle to direct water away from the structure and into the gutters. Left front.

Improperly-installed kickout flashing

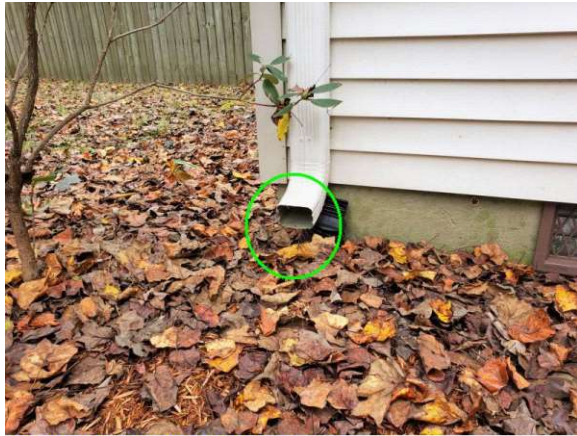
ACTION - REPAIR: Recommend repair by qualified licensed contractor. Downspout extension needed to direct water away from the structure. Lack of downspout extensions could allow water to collect around the foundation walls and cause foundation and moisture issues (see attached graphic).

Extend downspout / Right rear

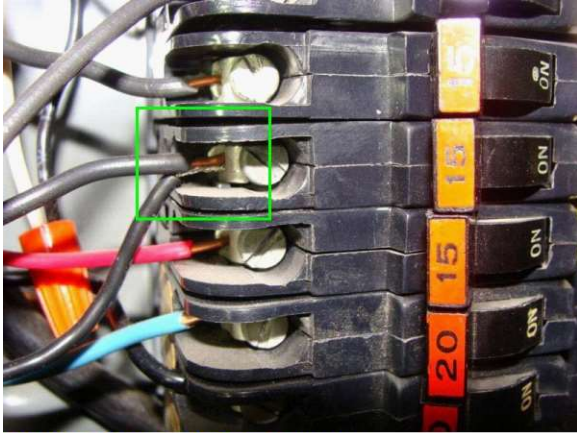
ACTION - REPAIR: Recommend prompt repair by qualified licensed electrician. Double taps (more than one wire connected to a single lug on a circuit breaker designed for only one wire connection). This could allow the wiring to overheat. 15-amp breaker, 3rd down on left side.

Double-tapped 15-amp breaker

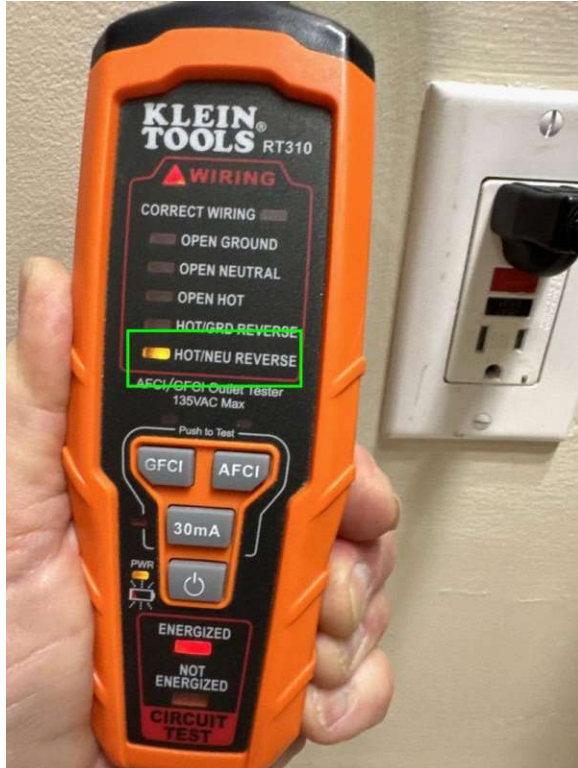
Improper wiring - Hot / neutral reverse

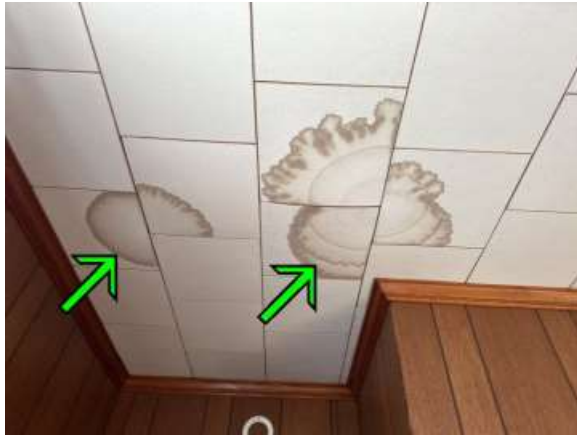
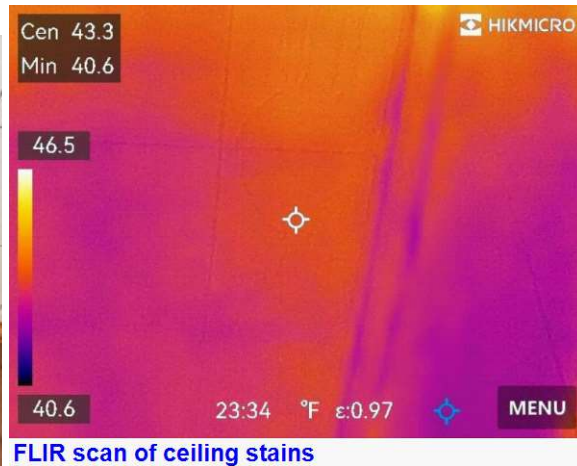
ATTENTION - MONITOR: Monitor closely for change in condition and need of repair by qualified licensed contractor. Ceiling stain. Stain appeared to be dried and was scanned with FLIR camera. No evidence of ceiling damage or active water leak at time of inspection.

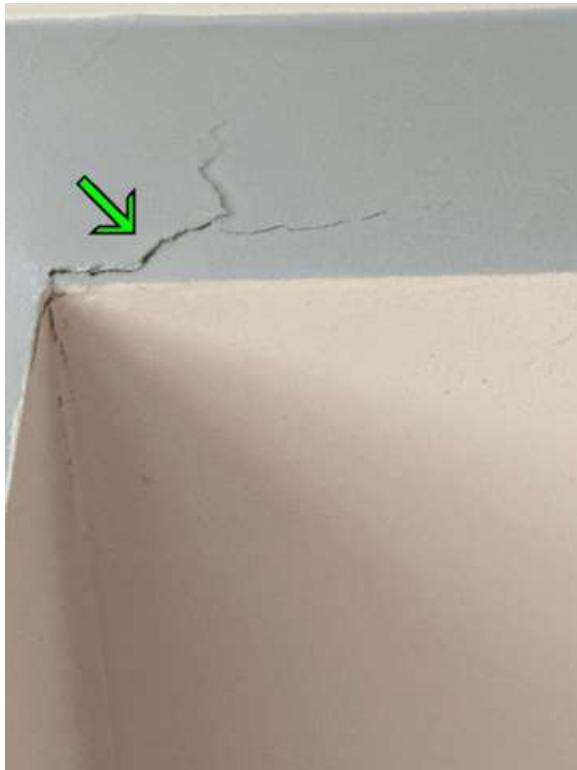
ATTENTION - MONITOR: Monitor closely for change in condition and need of repair by qualified licensed contractor. Typical cracking that appeared consistent with normal settlement.

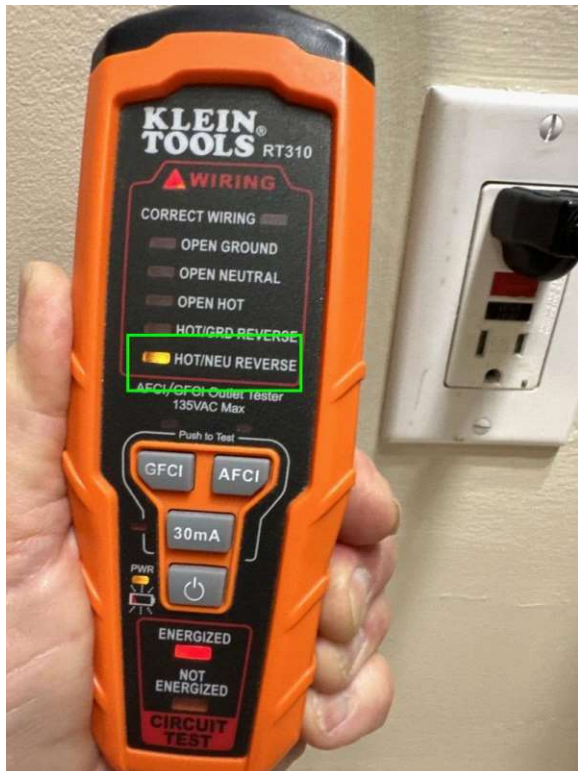
ACTION - REPAIR: Recommend repair by a qualified licensed electrician. Hot / neutral reverse (reverse polarity - improper wiring).

Improper wiring - Hot / neutral reverse

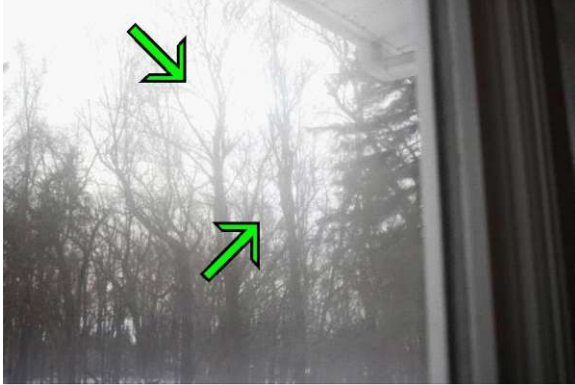
ACTION - REPAIR: Recommend repair by qualified licensed contractor. Broken thermal seal (window glass had a clouded appearance).

Clouded area / Lost thermal seal

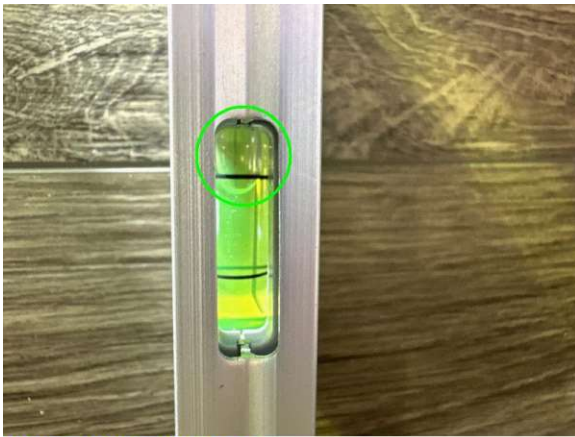
ATTENTION - MONITOR: Monitor closely for change in condition and need of repair by qualified licensed contractor. Minor sloping.

Minor sloping in floor

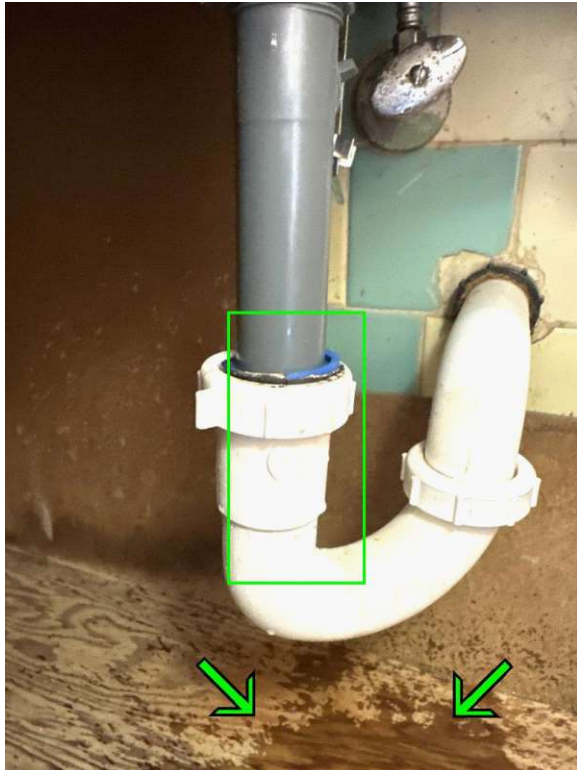
ACTION - REPAIR: Recommend repair by qualified licensed plumber. Active water leak.

Leak in waste / drain pipe

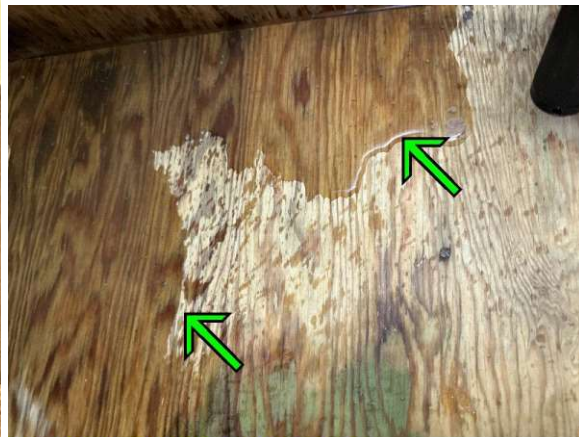
Area under waste / drain piping

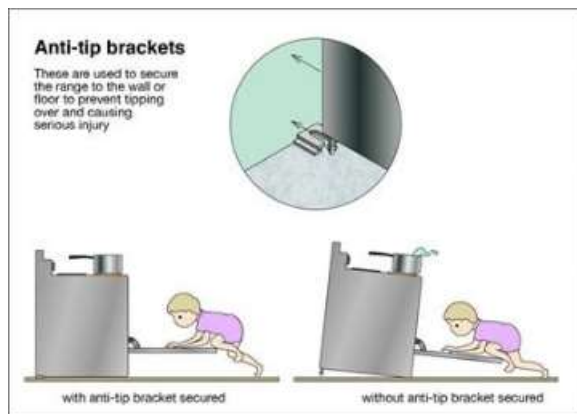
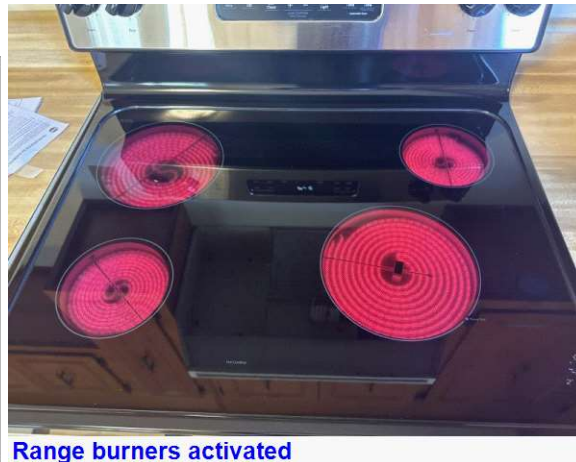
Brand: General Electric Type: Free-standing. Fuel source: Electric. **ACTION - REPAIR:** Recommend repair by qualified licensed appliance technician. No anti-tip bracket installed on free-standing range or oven. An anti-tip bracket prevents the unit from tipping over if weight is placed on the open oven door. See attached graphic.

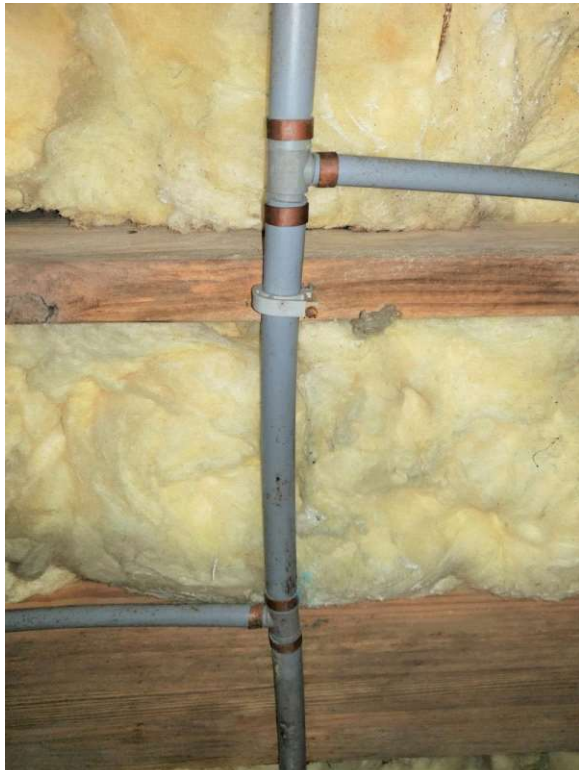
ATTENTION - MONITOR: Monitor closely for change in condition and need of repair by qualified licensed plumber. Some early versions of polybutylene piping developed leaks because of defects with the pipe material. No evidence of leaking at time of inspection.

Polybutylene (PB) piping in crawlspace

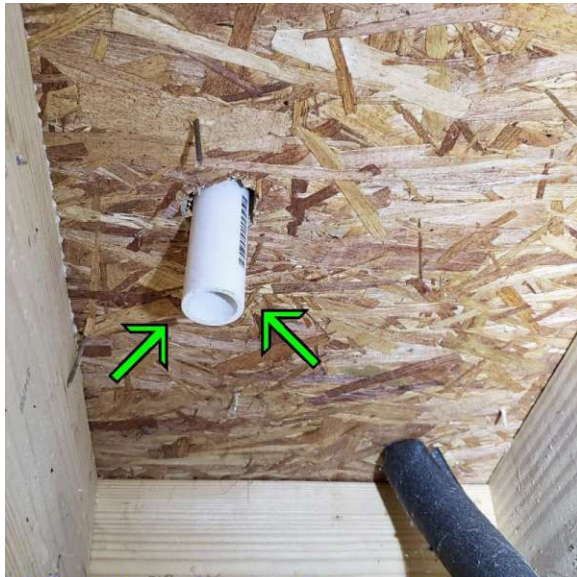
ACTION - REPAIR: Recommend repair by qualified licensed plumber. TPR discharge routed to crawlspace. The TPR discharge pipe should be routed to a visible, conspicuous location where it can be monitored.

TPR discharge pipe routed to crawlspace

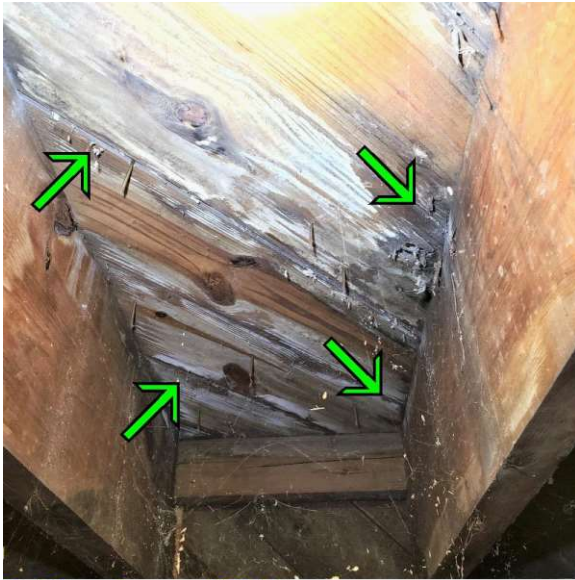
ACTION - REPAIR: Recommend repair by qualified licensed contractor. Damaged subfloor. Hole or opening in subfloor. Holes or openings should be properly sealed to prevent insect intrusion and energy loss. Visible portions of subfloor otherwise appeared functional and in good condition at time of inspection.

Subfloor damage / Right rear

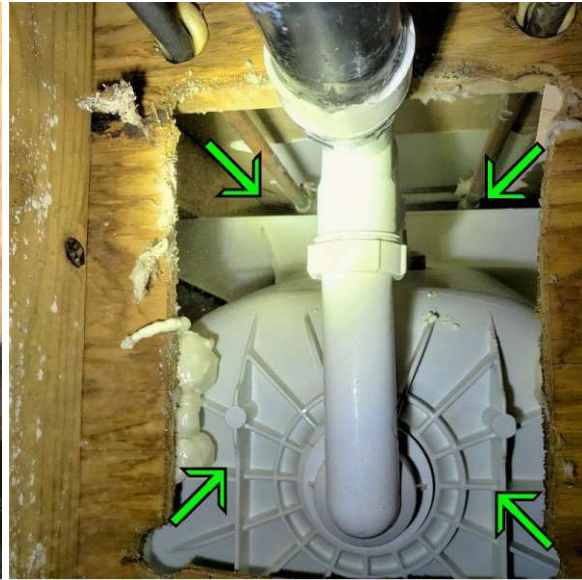
Opening in subfloor / Under hall bathroom

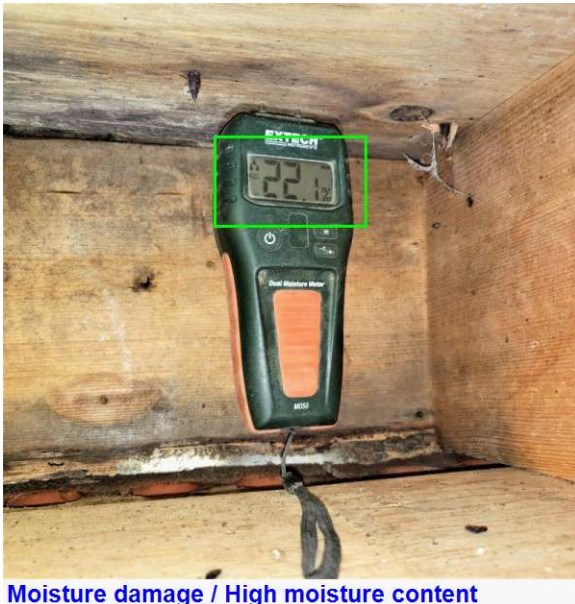
ACTION - REPAIR: Recommend repair by qualified licensed contractor. Moisture damage on subfloor & sill plate or rim joist. Rear under entry door from deck into living room. Moisture meter showed 22.1 % moisture level, wood felt damp when touched. Visible portions of the sill plate and rim joist otherwise appeared functional and in good condition at time of inspection.

Moisture damage / High moisture content

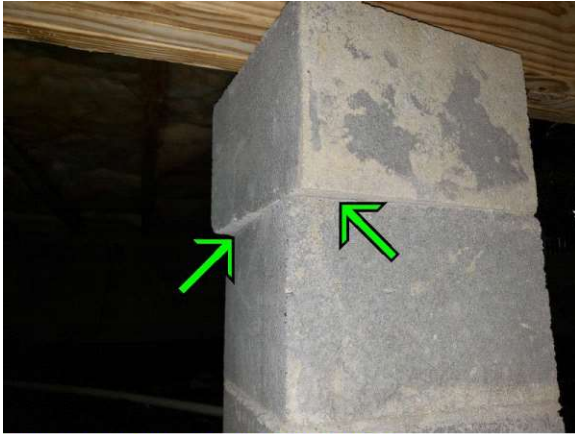
ACTION - REPAIR: Recommend repair by qualified licensed contractor. Dry stacking (no mortar between cinder blocks) in masonry support pier. Dry-stacked support piers could shift or collapse when load weight is placed on them. Located under main beam near front of crawlspace.

Dry-stacked block on support pier

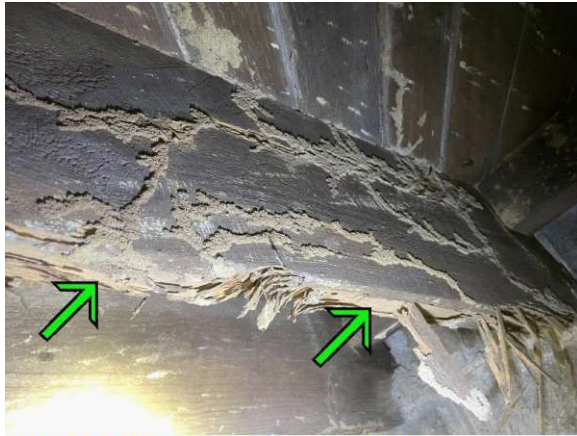
ACTION NEEDED - Evidence of possible wood-destroying organisms. Damage to several joists near front of crawlspace. Recommend further investigation by a qualified licensed pest control contractor prior to final closing. Heavy organic growth on several joists near right rear corner. Recommend further investigation by a licensed qualified mold contractor prior to final closing.

Possible WDO damage to floor joist

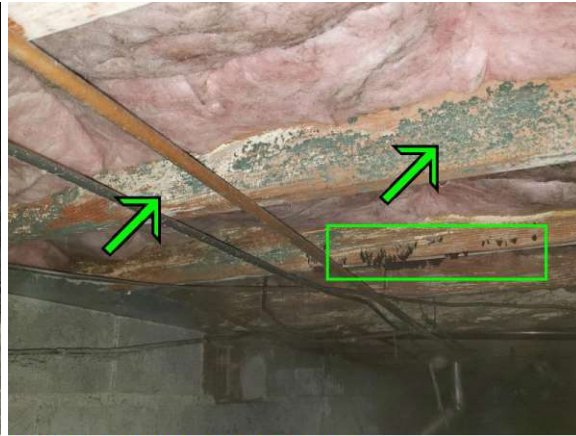
Organic growth on floor joists
