Premier Inspections LLC
5545 Mountcastle Road
Providence Forge, VA 23140
804-387-1747
steve@premierinspectionsva.com www.premierinspectionsva.com

Confidential Inspection Report

999 Easy Street

12/22/2023

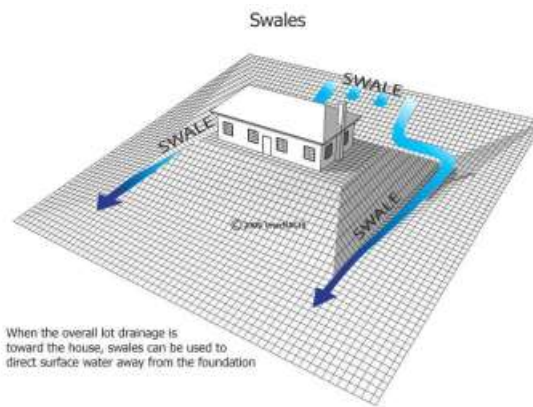
was flat or was sloped towards structure (negative grade). Poor grading could allow water to drain towards the structure or collect around the foundation walls and cause foundation or structural issues. Recommended ground slope away from the foundation is at least 1/2 inch per foot for a minimum of 6 feet. If proper ground slope cannot be achieved, it may be necessary to install a swale (see attached graphic).

Front yard slopes towards house

ACTION - REPAIR: Recommend correction by qualified licensed landscaper or grading contractor. Soil surface

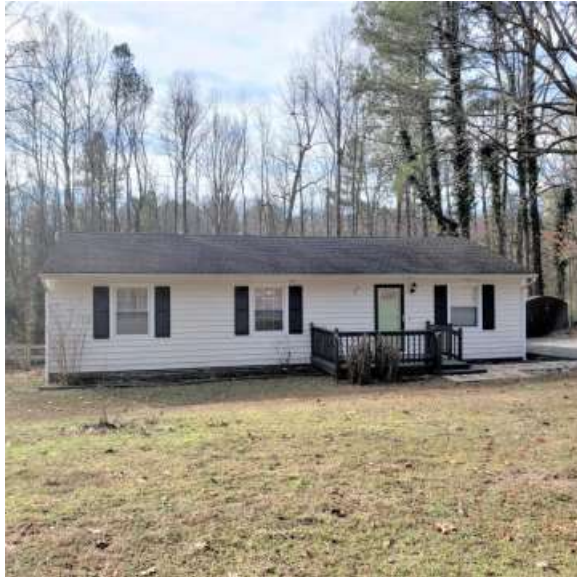
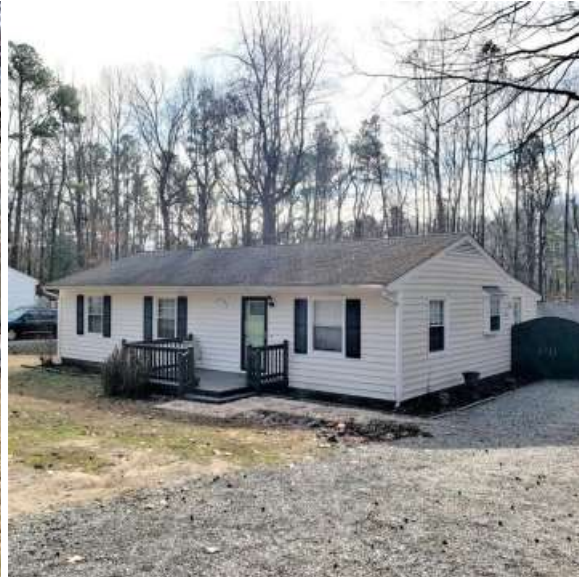
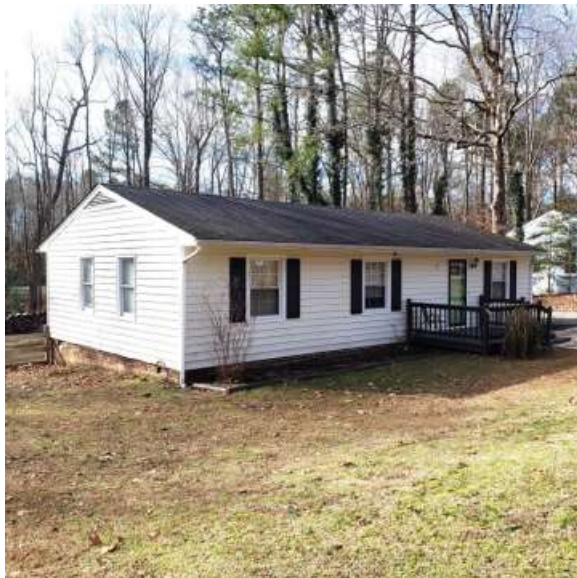
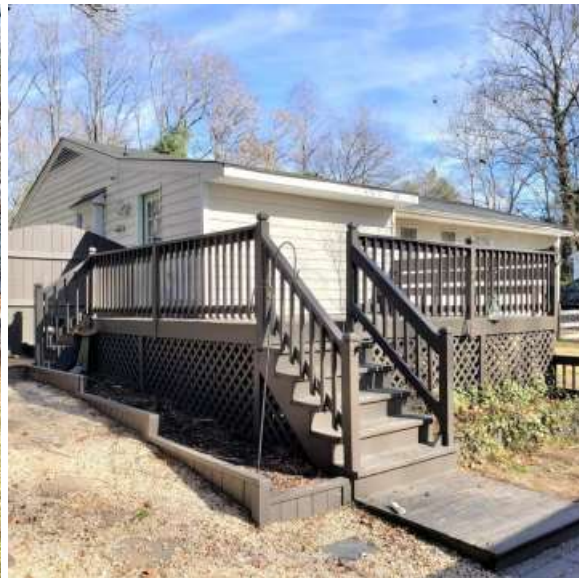
Structural Views:

Siding Condition:
Siding appeared functional with following exception: **ACTION - REPAIR:** Recommend repair by qualified licensed contractor to prevent water intrusion and structural damage. Missing siding at left front.

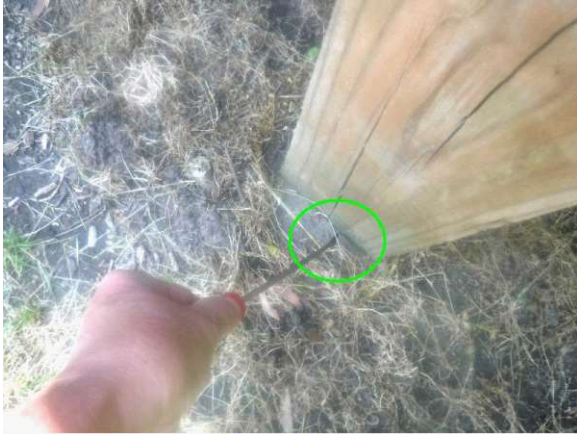
Above-ground portion of the support posts appeared functional and in good condition at time of inspection. The inspector probed the bottoms of the support posts for indications of wood rot below the surface. Support posts were set in soil.

Probing bottoms of support posts

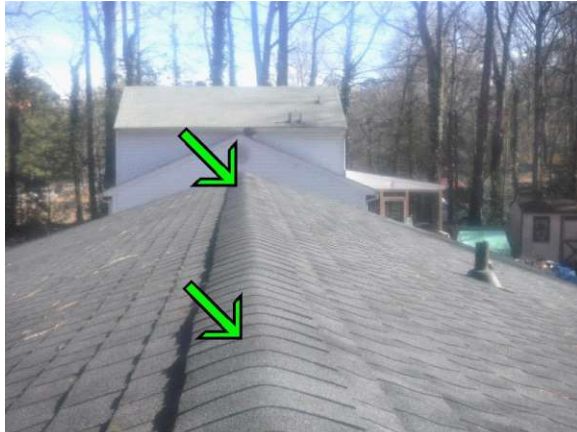
No evidence of sagging in ridgeline as viewed from the exterior.

No sagging in ridgeline

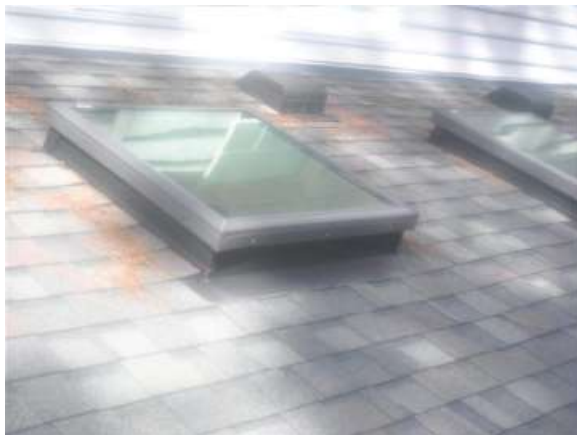
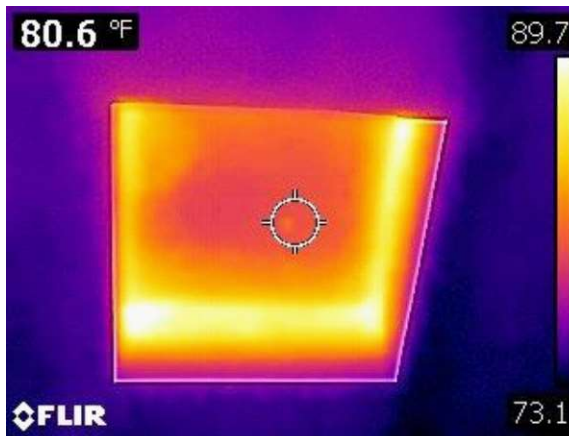
Skylights appeared functional and in good condition as viewed from the exterior. No exterior evidence of leaking at time of inspection. Predicting if the skylights may leak in the future is beyond the scope of this inspection. Interior portion scanned with FLIR camera, no evidence of leaking at time of inspection.

Skylight scanned with FLIR camera

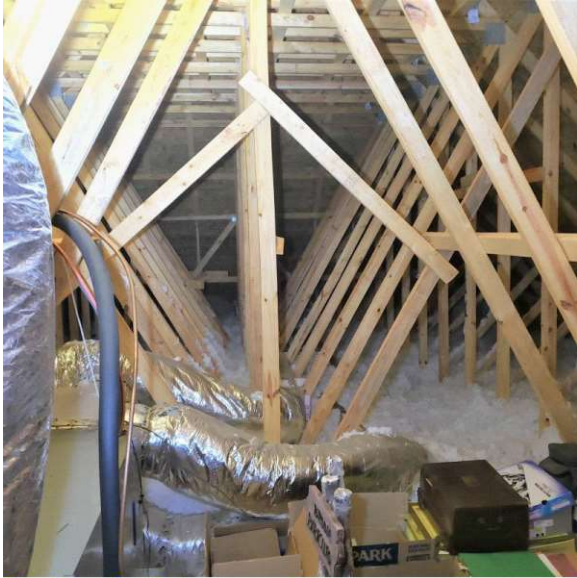
Truss system installed and appeared functional and in good condition.

Portion of attic truss system

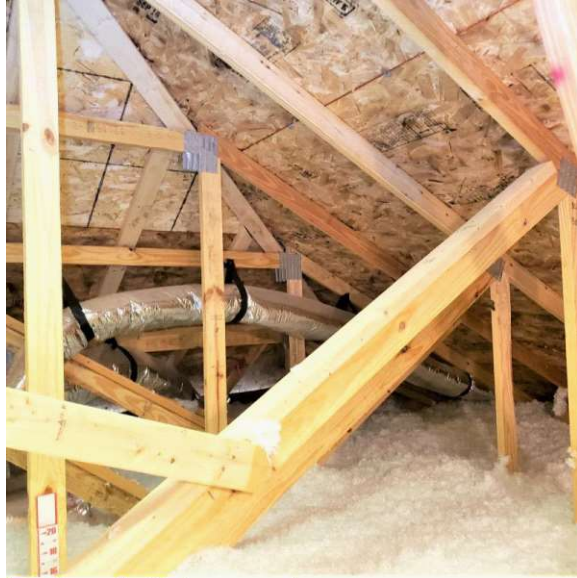
Portion of attic truss system

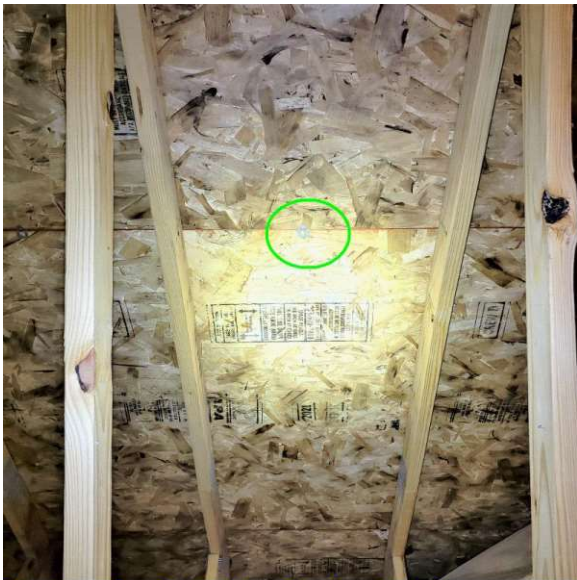
Oriented strand board (OSB). Ply clips ("H-clips") installed to prevent decking from sagging at the joints.

Portion of roof decking / H-clip circled

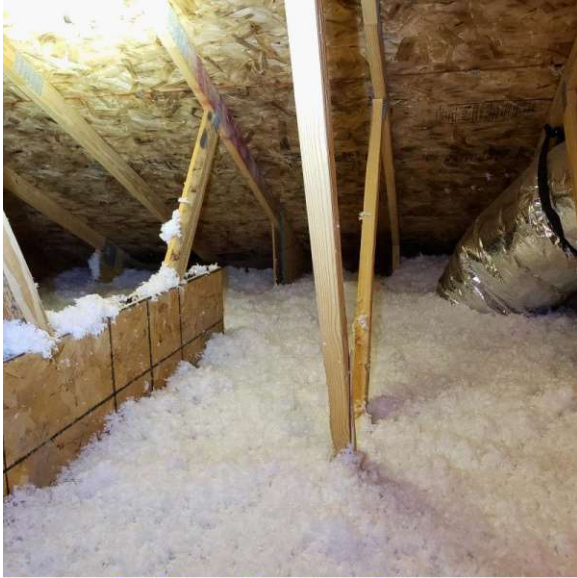
Loose fiberglass. Insulation level appeared to be sufficient. Insulation not in contact with roof decking.

Portion of attic insulation (typical)

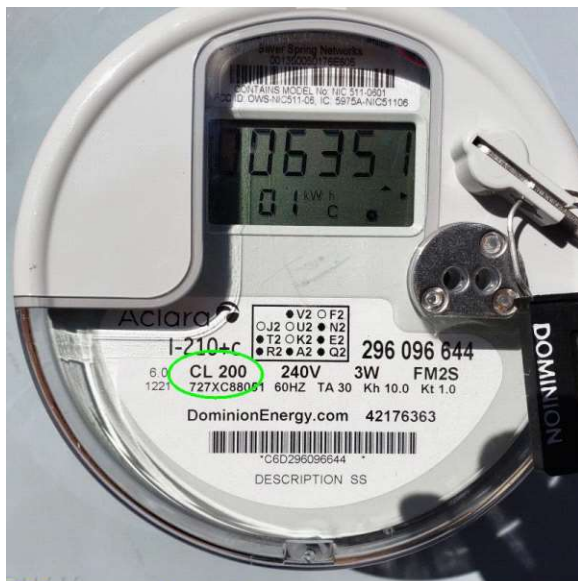
200 amp. Meter base appeared serviceable. Meter seal was unbroken.

200 amp service meter

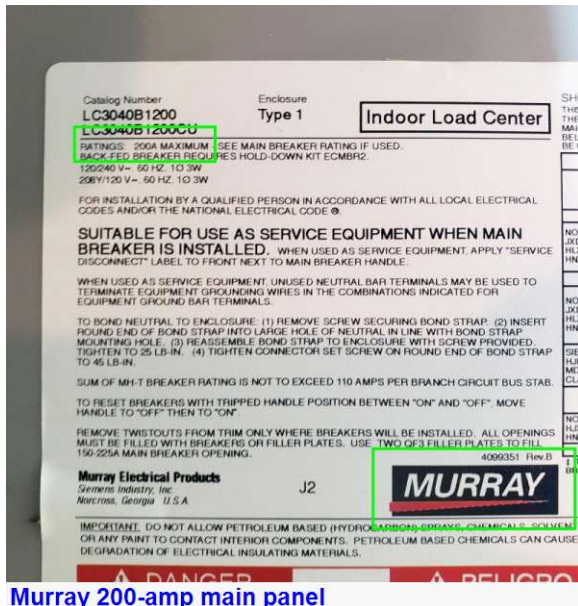
Brand: Murray, Panel Rating: 200 amps. Devices: Circuit breakers.

Murray 200-amp main panel

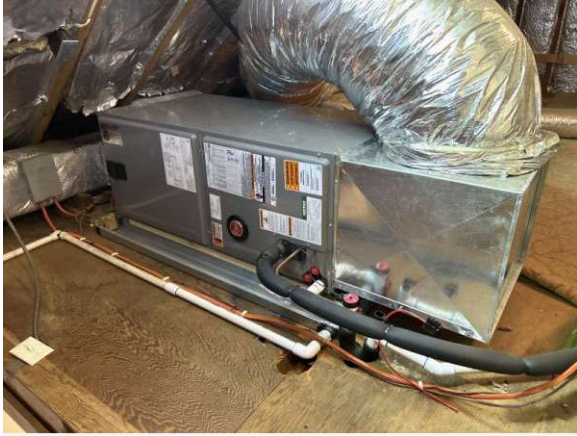
Air handler (heat pump). Location: Attic.

Air handler in attic

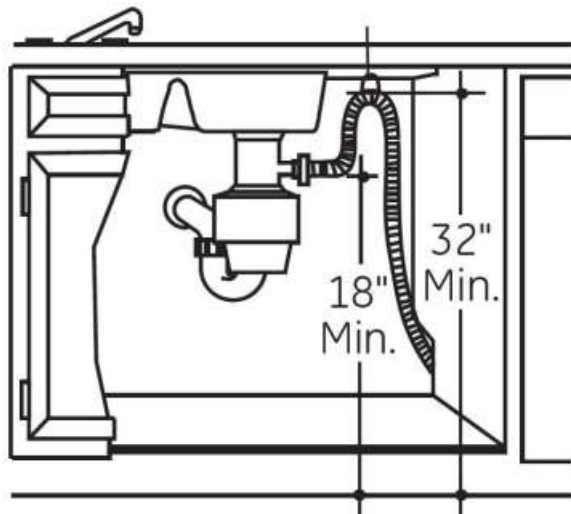
Brand: Bosch. Dishwasher tested on one cycle and appeared to function properly. This does not imply that the other cycles work nor does it imply that the dishwasher will clean the dishes to your requirements. **ACTION - REPAIR:** Recommend repair by qualified licensed appliance technician. No air gap or high loop on drain line. An air gap or high loop is needed to prevent waste water from cycling back into the dishwasher. See attached graphic.

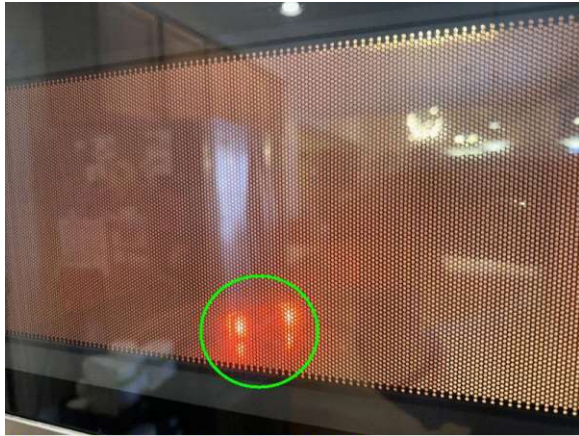
Brand: Bosch. Type: Countertop. Microwave tested using a microwave tester and appeared functional and in good condition.

Microwave tester activated - OK

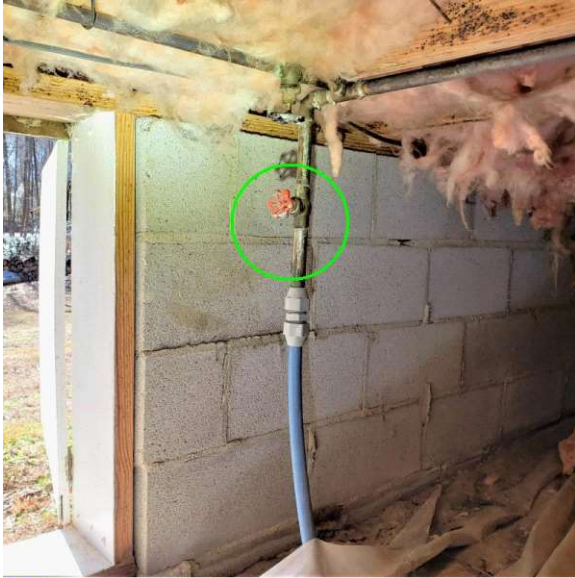
Crawlspace. Main water shutoff appeared functional and in good condition. Testing of main water shutoff is beyond the scope of this inspection.

Main water shutoff

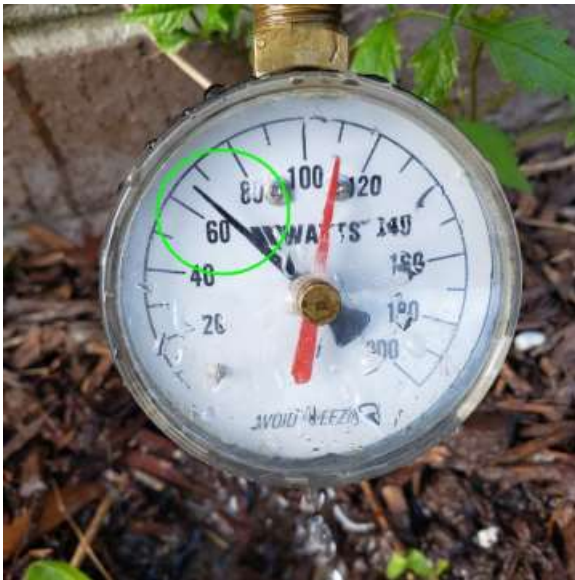
Water pressure checked at exterior hose bib. Water pressure was 40 - 80 psi (within acceptable range).

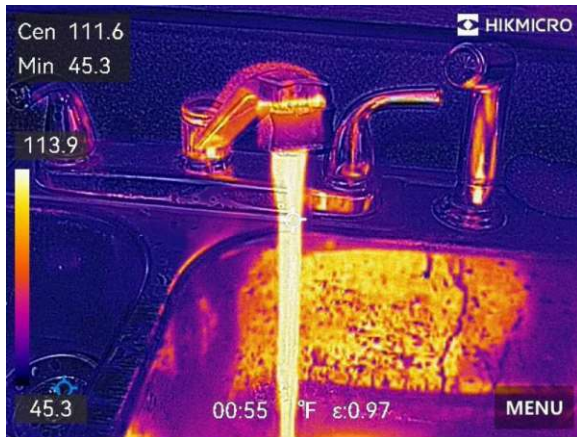
Hot water verified by FLIR scan at two locations: Kitchen and hall bathroom.

Kitchen - 113 degrees F

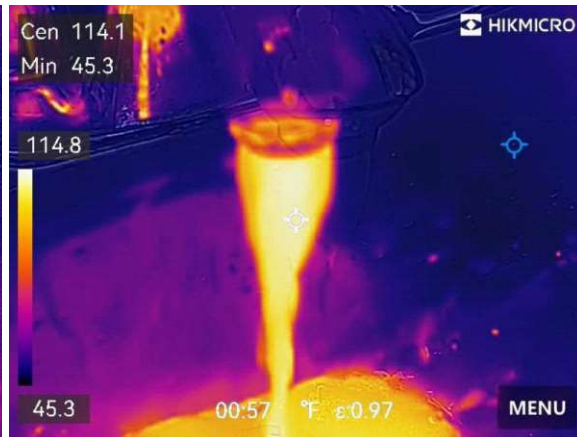
Hall bathroom - 114 degrees F

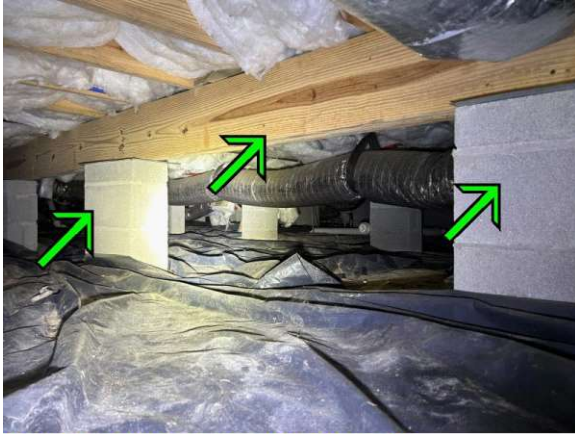
Wood beam (solid or laminated). Main beam appeared to be functional and in good condition.

Portion of main beam and supports
